INDOOR AIR QUALITY ASSESSMENT

**Greenfield Middle School
195 Federal Street
Greenfield, Massachusetts**

Prepared by:
Massachusetts Department of Public Health
Bureau of Environmental Health Assessment
June, 2000

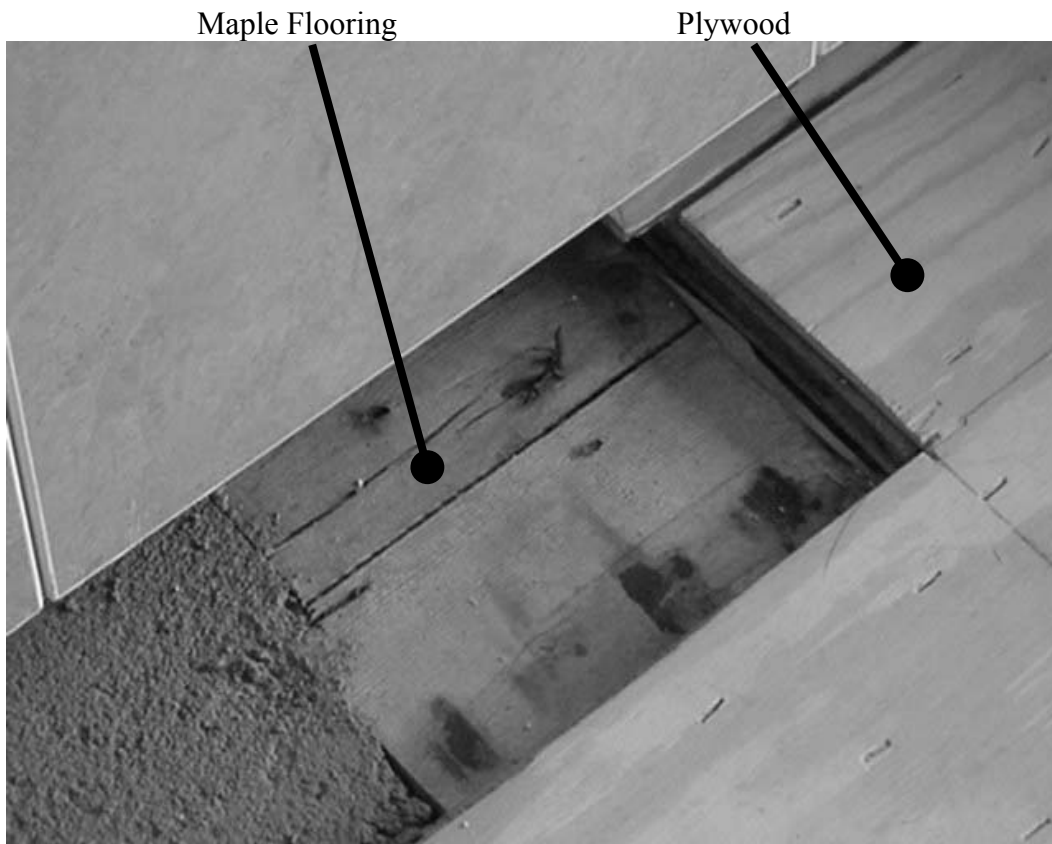
Picture 1

The building was evaluated during a sunny day, with an outdoor temperature of 56° F and relative humidity of 18 percent. No active leaks were observed and no visible, accumulated moisture was noted on walls. No mold-type odors were noted in the building, with the exception of a dirt-lined pit in the floor where water utility pipes enter the basement. Standing water was noted in soil in and around the boiler room. Relative humidity indoors was measured in a range of 11 to 18 percent. The floor system appeared to be plywood laid over tongue-in-groove maple (see Picture 1). The supporting structure beneath the floor wood is brick (see Picture 2). The source of water-damage to the building was attributed by Greenfield town officials to the removal of drainpipes connected to roof drains. Former roof drains missing drainpipes were noted in the building (see Picture 3). Plywood flooring appeared dry, however plywood around seams in the floor appeared to be water stained (see Picture 4). Seams of plywood also appeared to be widened due to shrinkage. Moisture readings taken at random were either non-detectable or in a range of 8.0 to 8.7 percent in the plywood floor with measurable levels of moisture. The tongue-in-groove maple floor yielded a moisture content measurement in a range of 10.2 to 10.7 percent.

Flooring of the GMS

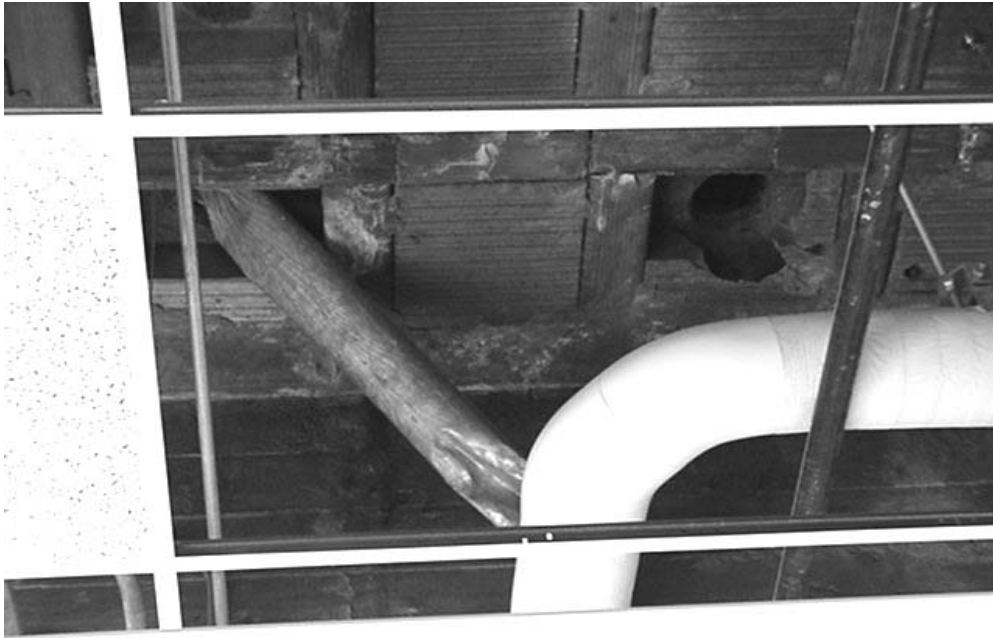
Picture 2

Brick Support Structure of Floor

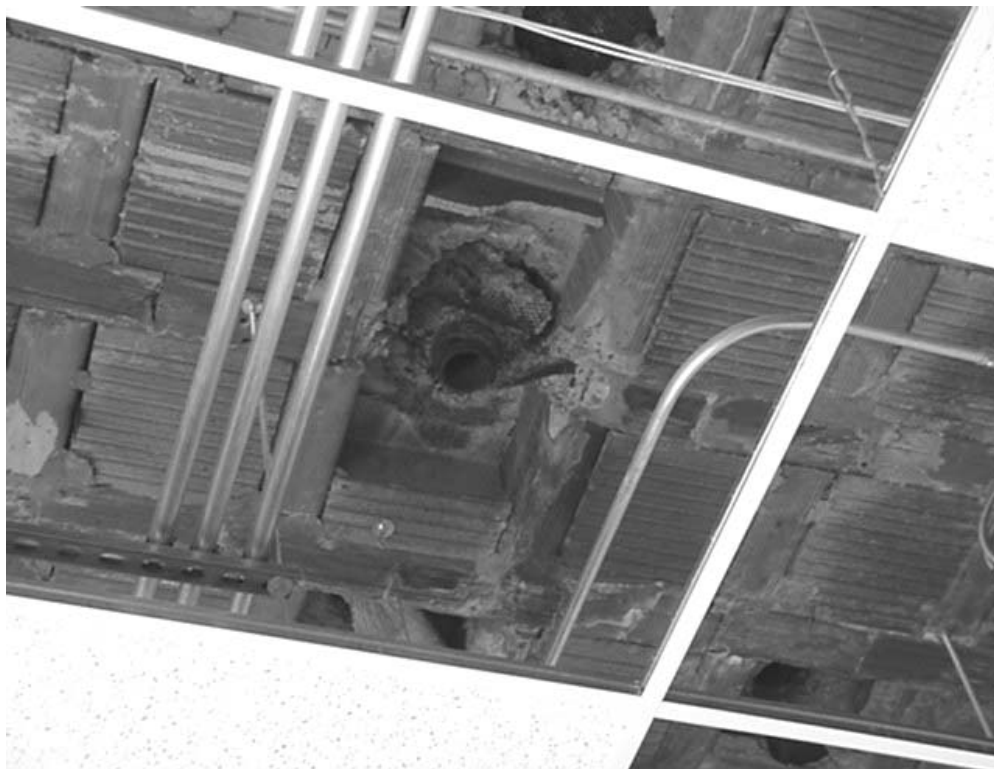
Picture 3

As reported by Mr. Fulton, the building has experienced water damage from water penetration resulting from displaced roof drainpipes. Mold testing was conducted on February 10, 2000 (ATC, 2000). ATC noted bird waste and significant water damage to walls and flooring in the building. ATC concluded that microbiological testing found mold and bacterial growth. ATC recommended that bird waste be cleaned and disinfected by individuals with personal protective equipment. It was also recommended that water damaged flooring be replaced.

Disconnected Roof Drain

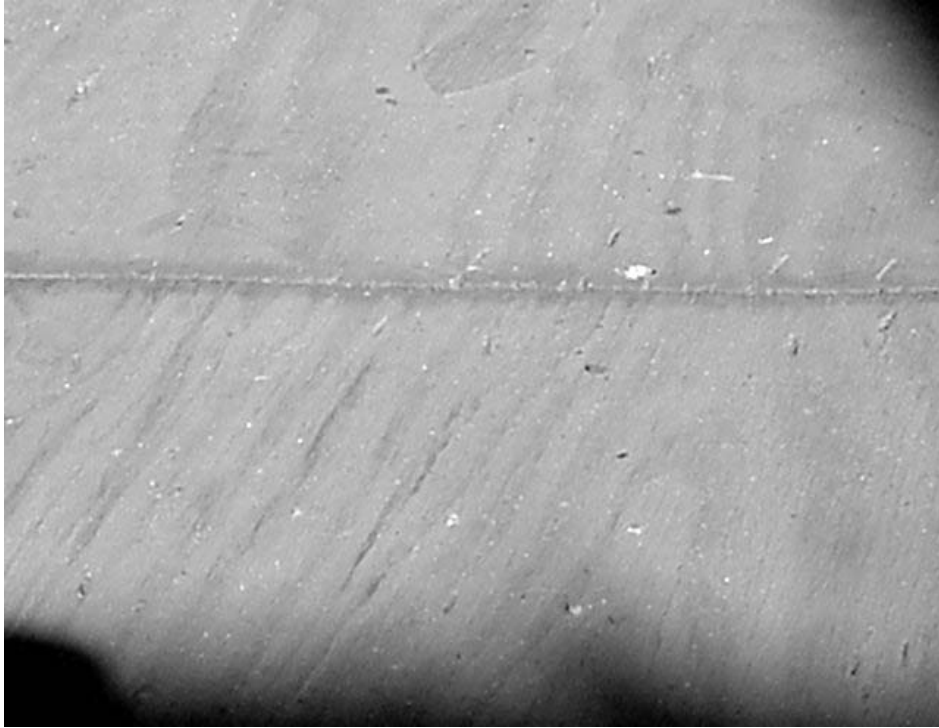
Picture 4

Building materials can also absorb moisture from air. As relative humidity increases, moisture concentration can increase. The American Conference of Governmental Industrial Hygienists (ACGIH) recommends that porous materials be dried with fans and heating within 24 hours of becoming wet (ACGIH, 1989). If porous materials are not dried within this time frame, mold growth may occur. Once mold growth has occurred, disinfection of these materials may be possible, however since wood is a porous surface, disinfection may be ineffective. Please note that the moisture testing was done on exposed surfaces of floor. If water were to flood a floor, it is possible that moisture could become

trapped beneath the plywood and/or maple flooring to serve as a reservoir for moisture.

Water Stain along Plywood Floor Seams

Care should be given in selecting a floor covering that would not support mold growth if these moisture reservoirs exist. Further moisture testing on the sub-flooring should be done to determine if these moisture reservoirs exist.

3. Evaluate whether moisture pools from water damage exist beneath plywood and/or maple flooring. If moisture pooling exists, employ appropriate methods to both remove moisture and disinfect mold contaminated materials. If mold contamination exists and disinfection is inadequate, consider removing materials.

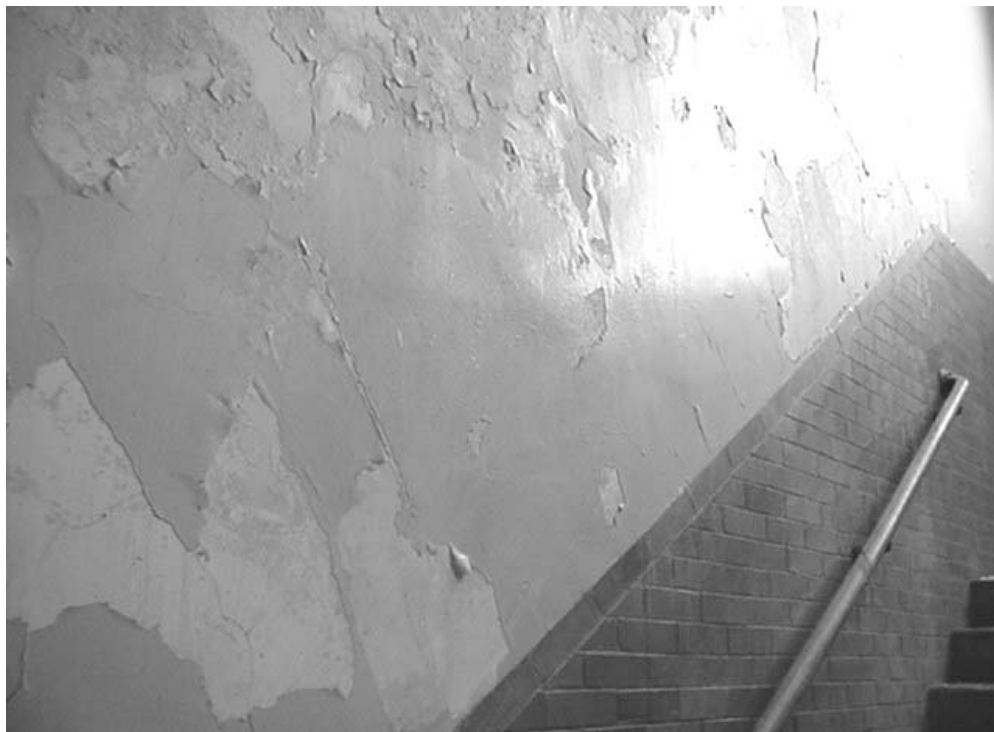
Picture 5

Plaster and paint in stairwells exhibited signs of water damage. Flat paint surfaces did not have measurable levels of moisture. Moisture measurements in bubbled paint (see Picture 5) or exposed plaster were non-detectable. The interior of bubbled paint on this wall had moisture measurements in a range of 18 to 41 percent, indicating water accumulation behind the paint surface. Both paint and wall plaster can serve as growth media for mold, especially if wetted repeatedly.

Bubbled Paint Sampled for Moisture Concentration

8. Remove bubbled paint and examine wall plaster for mold growth. If mold growth is present, disinfect with an appropriate antimicrobial agent.
9. Seal construction barriers with polyethylene plastic and duct tape to create a secondary barrier to prevent migration of renovation generated pollutants into finished areas.

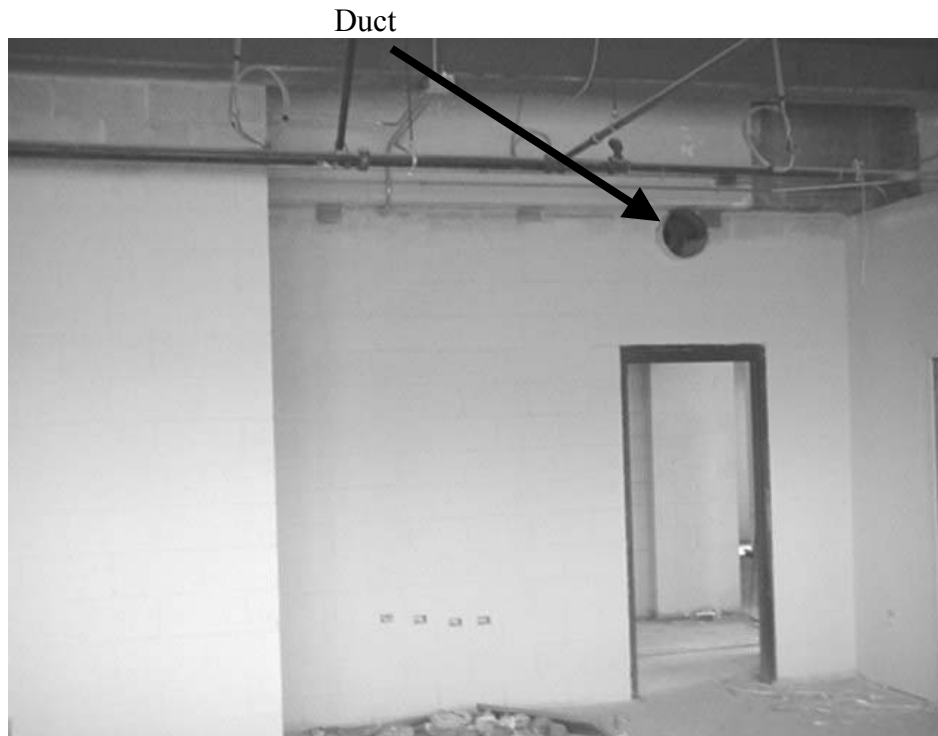
Picture 6

Ductwork was partially installed in the building. Openings to ductwork were noted in classrooms through interior walls above hallway doors (see Pictures 6 through 8). Each of these duct openings was not sealed to prevent renovation-generated dust. Ductwork to be installed was found stored on the floors of classrooms (see Picture 8). These ducts were heavily coated with dust (see Pictures 9 and 10). It is good practice to isolate newly installed ductwork to avoid dust contamination of these materials. Since it appears that these ducts were open throughout the building, there is ample opportunity for both installed and/or stored ductwork to be contaminated by renovation pollutants. Therefore, the design of the ductwork system must be assessed to determine how it may be impacted by renovation activities.

Unsealed Duct above Classroom Hallway Door

6. Clean all uninstalled ductwork of dust and store in a manner to prevent contamination with renovation-generated dust.
7. Clean the interior of all installed ventilation system ductwork. Seal each end of installed ductwork to prevent contamination.

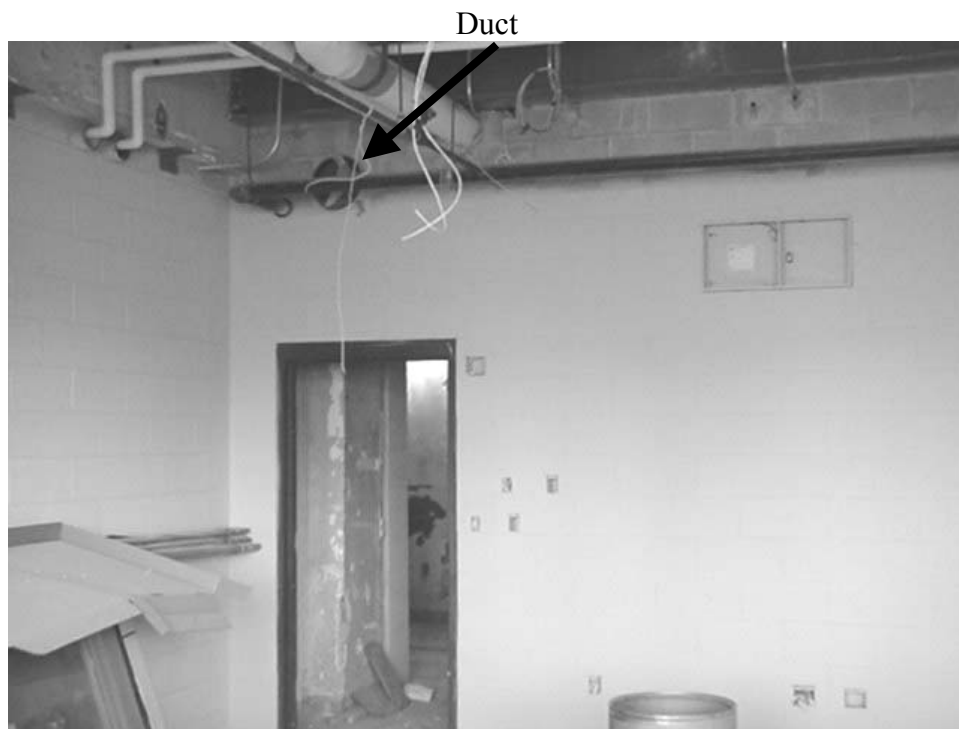
Picture 7

Unsealed Duct above Classroom Hallway Door

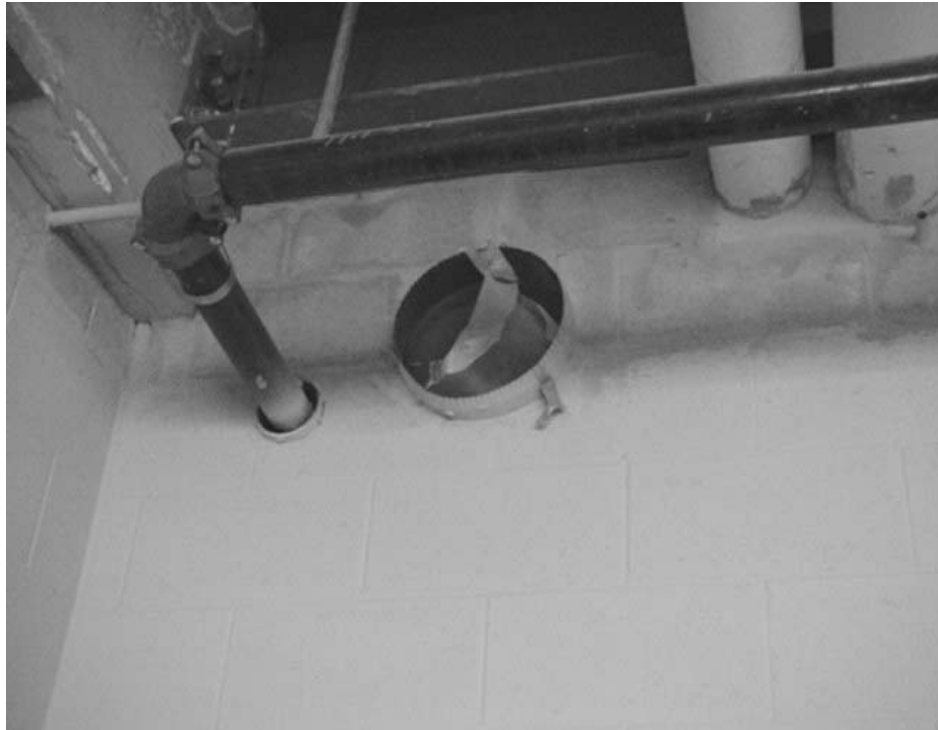
Picture 8

Close-Up of Unsealed Duct above Hallway Door

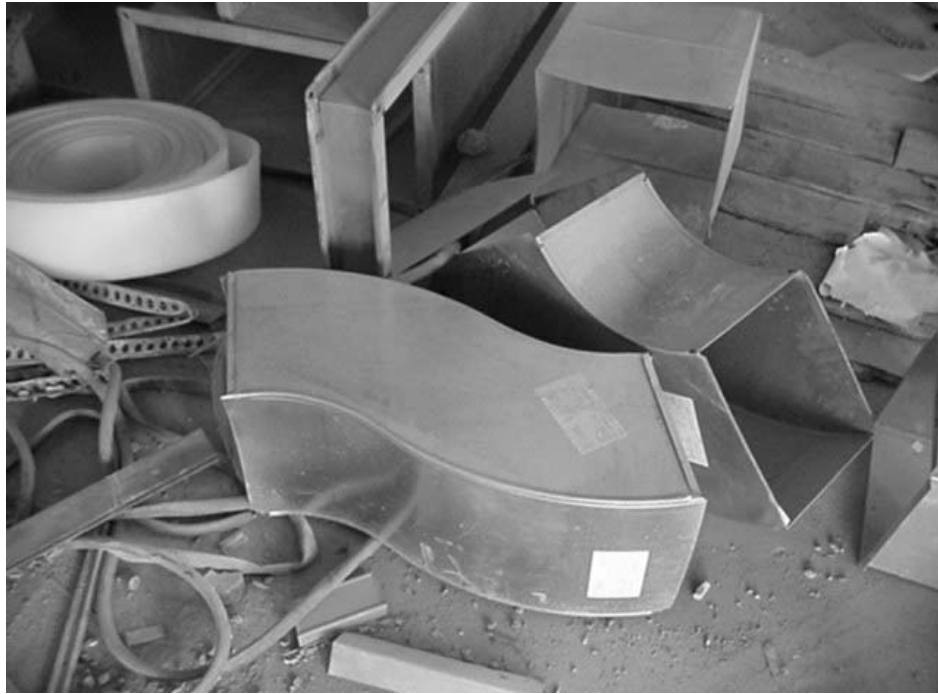
Picture 9

Ductwork to Be Installed Stored on Classroom Floor

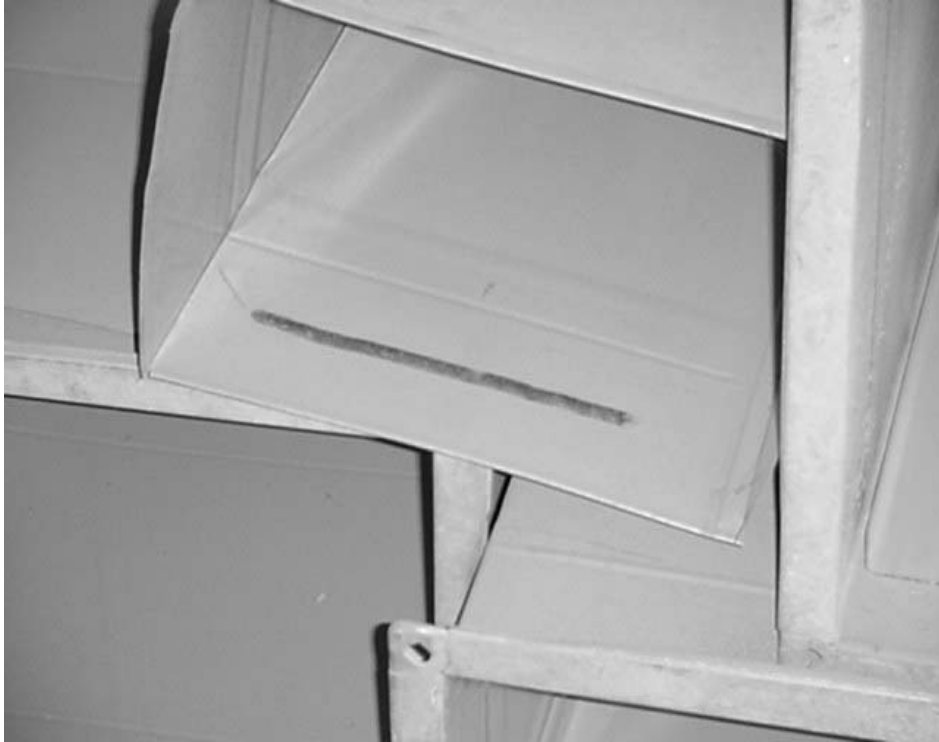
Picture 10

Dust Contaminated Ductwork, Line Drawn in Dust by BEHA Inspector

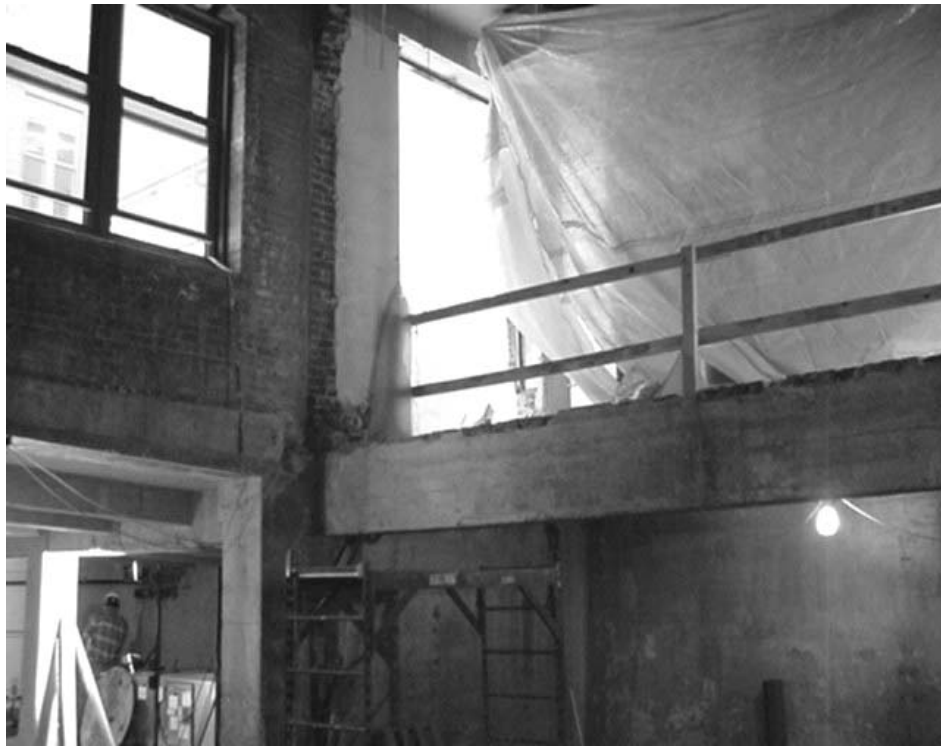
Picture 11

Numerous openings to the buildings were noted (see Pictures 11 and 12). Signs of pigeon infestation including pigeons, feathers (see Picture 13) and pigeon waste (see Picture 14) were noted in numerous indoor areas. Insulation on pipes appeared to be contaminated with pigeon waste (see Pictures 15). In one case, it appears that bird's have nested inside ceiling brickwork. Significant bird waste was noted along a catwalk above the auditorium stage (see Pictures 16 and 17). Bird wastes in a building raise three concerns: 1) diseases that may be caused by exposure to bird wastes, 2) appropriate measures for clean up of bird waste and 3) the appropriate method for disinfection of plywood.

Openings in Plastic Sheeting in Basement

1. Remove birds from the interior of the building and seal all means of egress for birds to enter the building.
2. Clean bird wastes from contaminated materials. Remove accumulated bird wastes from flat, non-porous surfaces and disinfect with an appropriate antimicrobial agent. Once disinfected, each treated area should be cleaned to ensure the removal of residual bird waste and cleaning materials. Removal of contaminated porous materials (e.g., pipe insulation) may be the only appropriate measure to remove bird wastes from these materials. In order to assist you with this project, we have enclosed a copy of an issue of the Centers for Disease Control *Morbidity and Mortality Weekly Report* for July 10, 1998 (see [Appendix A](#)), which covers the clinical aspects as well as clean up associated with bird waste. Dependent on the scale and scope of the contamination, you may wish to consider consulting a professional cleaning company that has had experience in cleaning buildings that have experienced bird infestations.

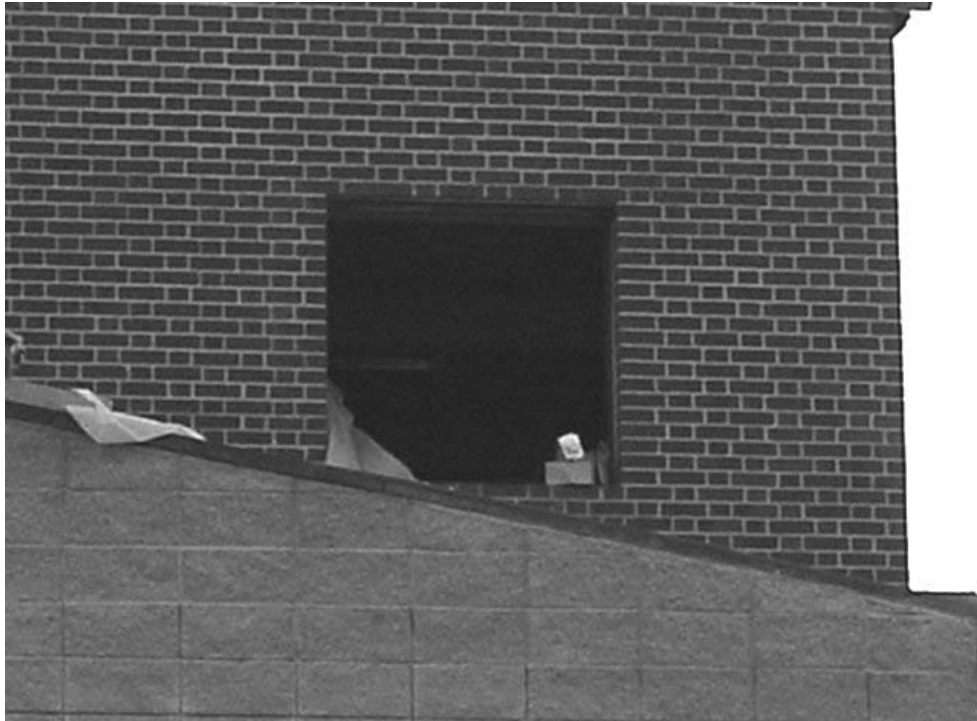
Picture 12

Open Window on Second Floor

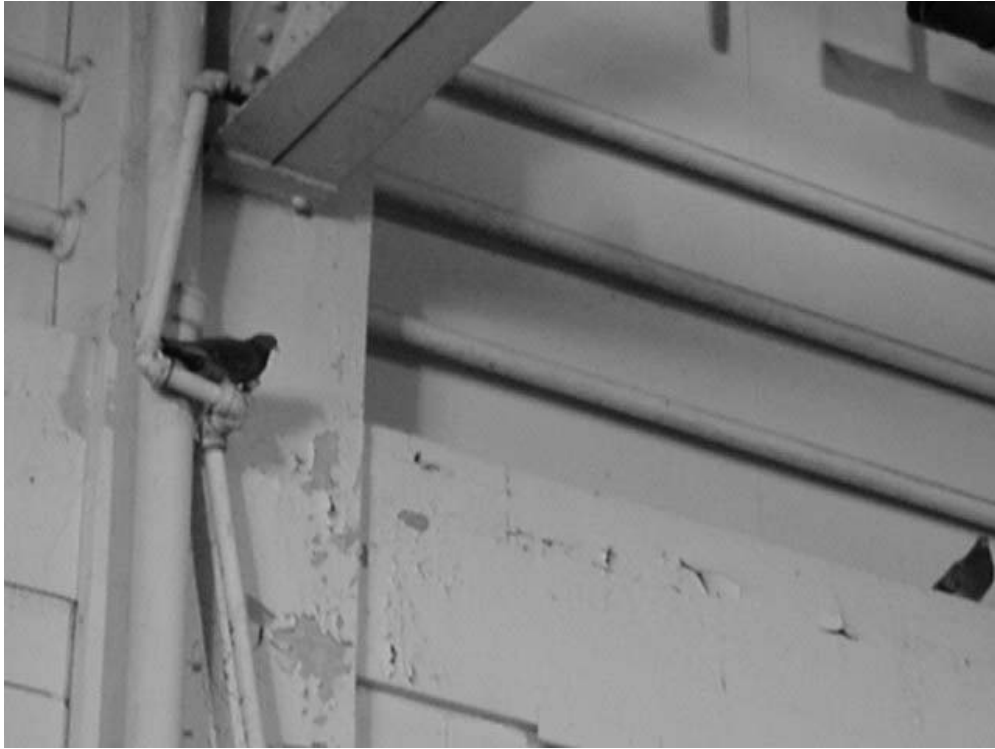
Picture 13

Pigeon inside the Gymnasium

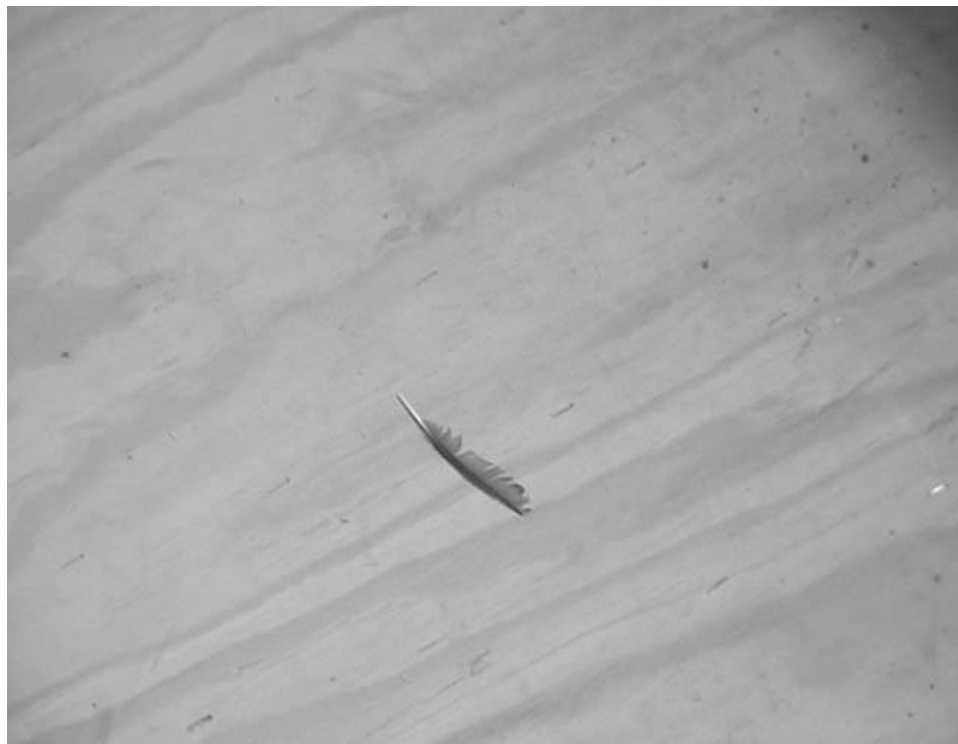
Picture 14

Bird Feather on Floor of Classroom

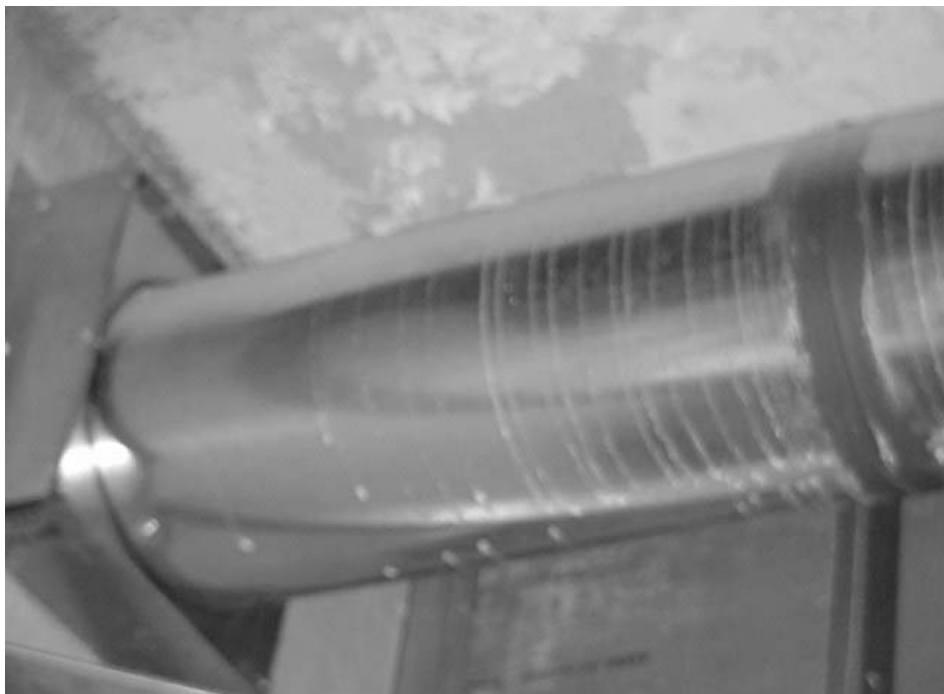
Picture 15

Bird Wastes Contaminated Ductwork

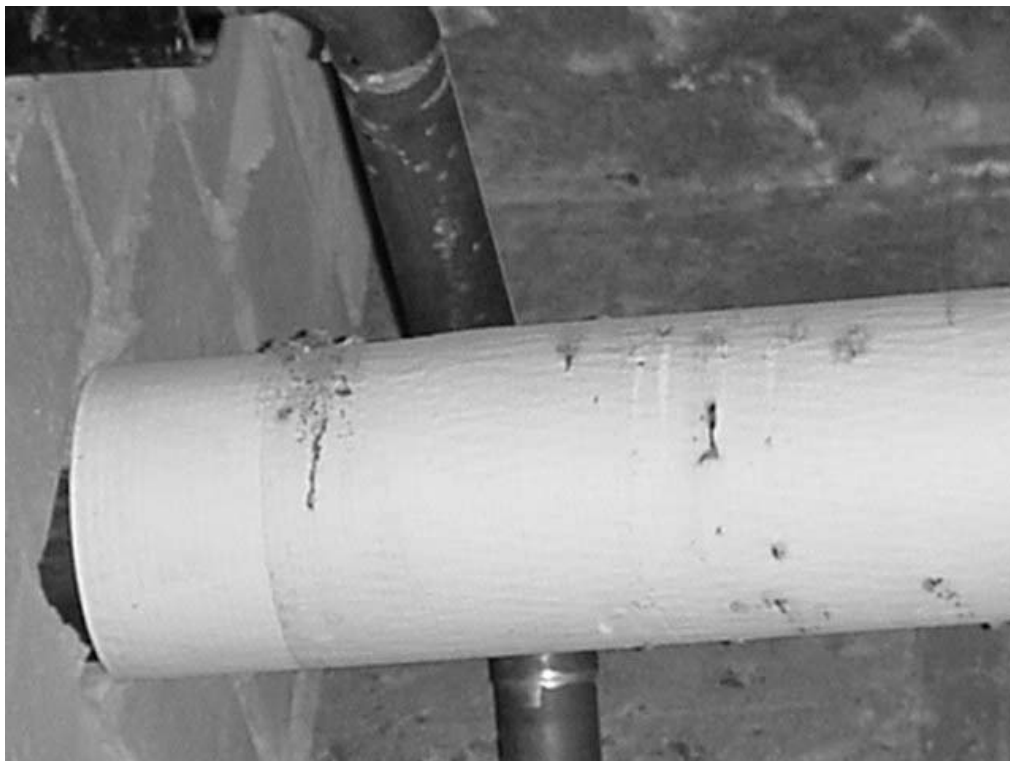
Picture 16

Bird Waste Contaminated Pipe Insulation

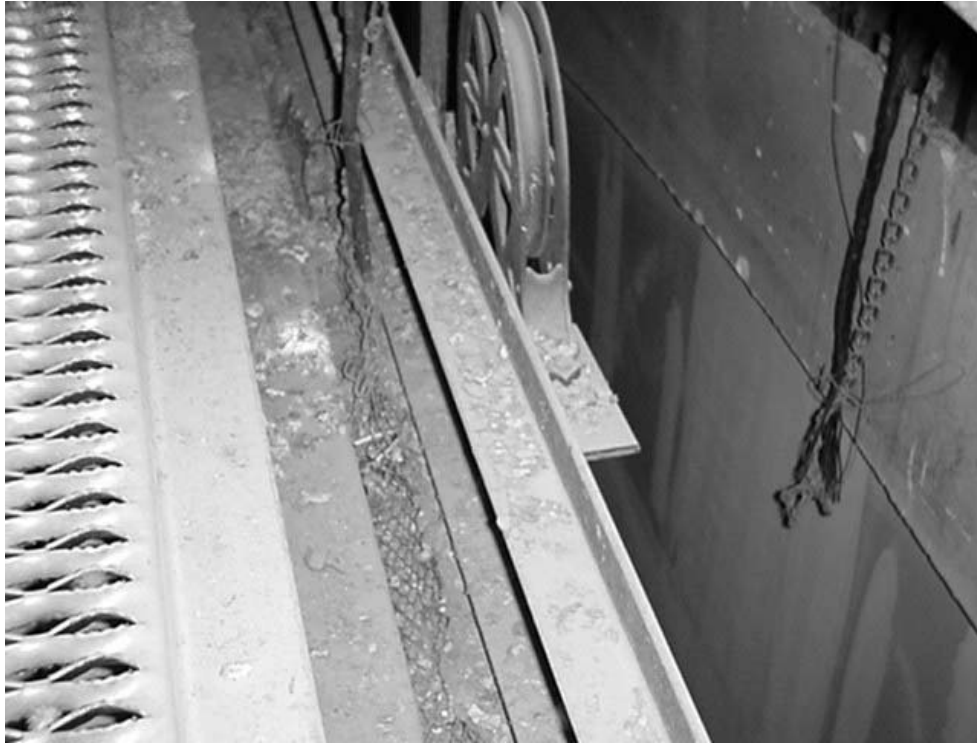
Picture 17

Bird waste Contaminated Beams above Auditorium Stage

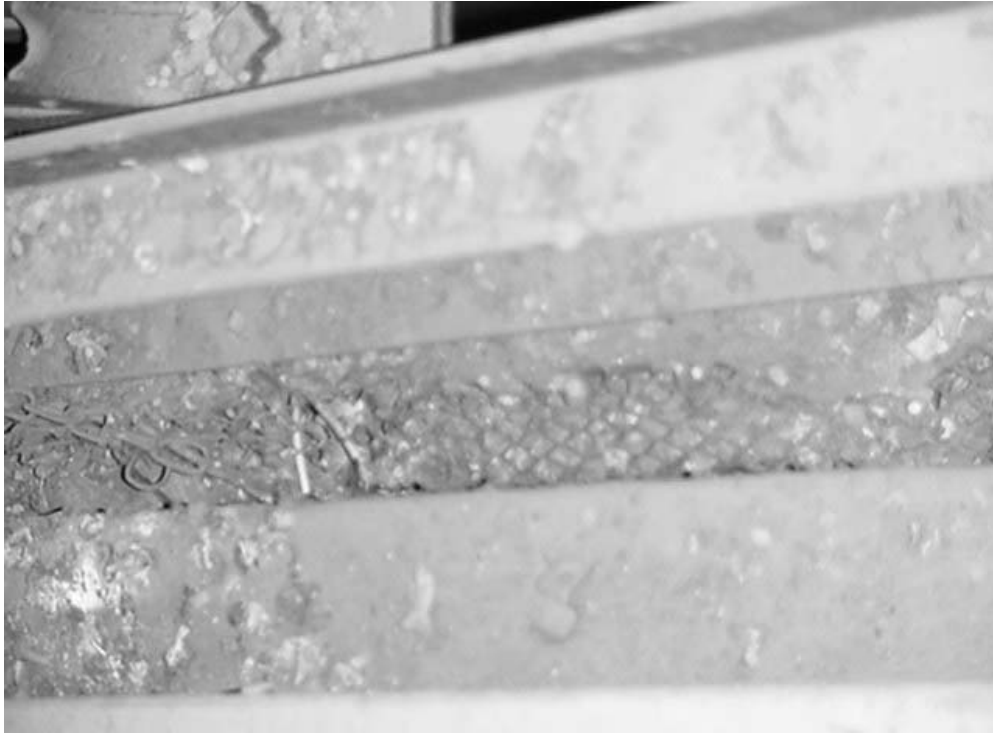
Picture 18

Close-Up of Bird Waste Contaminated Beam
